Manhole Inspection Summary

Manhole # S45UU_004MH

Insp Date: **2/8/07 8:43 AM**

Location Address: **2700 TIVOLY AVE**

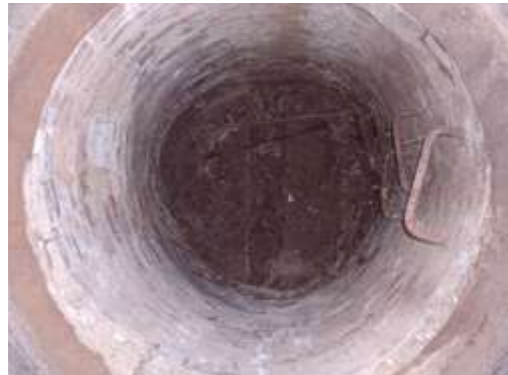
Top View

Barrel infiltration. Corroded steps. Bench and Channel debris.

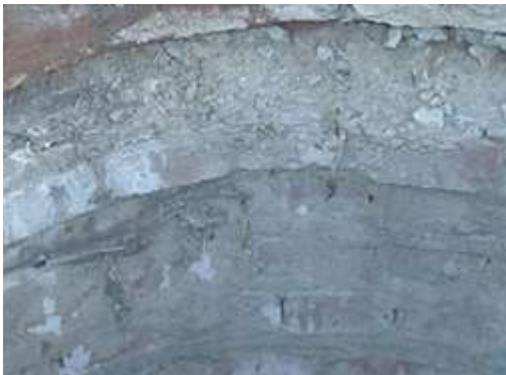
Defect

☒ **Leaks**

Condition: ☐ Sound ☐ Cracked ☐ Root Intrusion ☐ Loose Brick ☒ **Deteriorated**

Infiltration: ☐ None ☒ **Joint** ☐ Cracks ☐ Mortar ☐ Roots ☒ **Wall**

Frame leaks. Frame offset. Adjustment deterioration and infiltration.

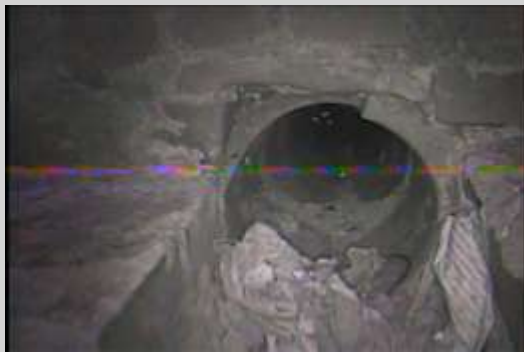
8 in. Circular Gravity Sewer
Pipe Out @ 12 O'Clock

Deposits: ☐ None ☐ Mud ☐ Sludge ☒ **Debris** ☐ Grease

Silt Depth: **2** (in.) Deposits Extent: **Light**

Infiltration: **None** Pipe Seal Cond: **Broken**

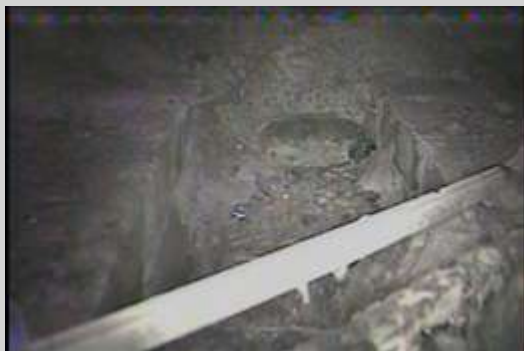
Pipe In @ 6 O'Clock

Infiltration: **Evidence** Pipe Seal Cond: **Unknown**

Connects To: **Stub connection / abandoned**
